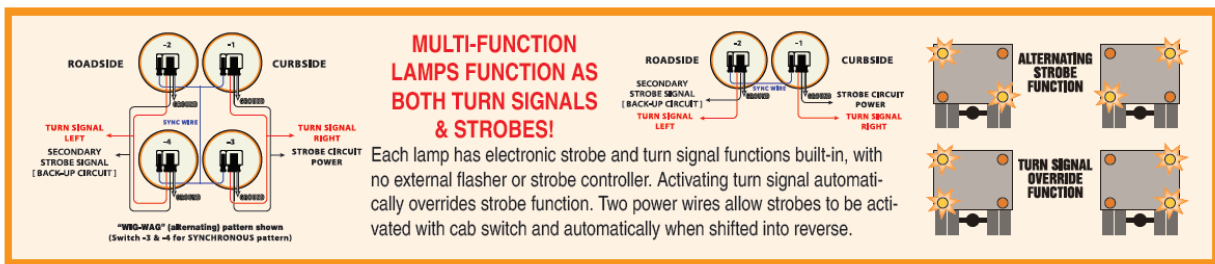
In a dual or quad strobe setup, applying the turn signal and shutting it off causes one of the strobes on the opposite side to quit strobing. As a quick fix on the smart strobes for when the 867SA-1 and 867SA-2 both receive power constantly for strobe input (both have T2 connected together in the harness) and all the lights are connected through the sync line, disconnecting power from T2 on the 867SA-2 should resolve the issue.

Please note that the wiring diagram is technically correct but is consistently being misinterpreted. The Roadside black wire is marked as a Secondary Signal (Back-up Circuit). If the customer doesn't hook this circuit to the back-up circuit they need to remove that black wire from the power completely. As said above, they can clip the center pin (T2) from the back of the light or they can buy the B817-48 or B417-48 for that side of the vehicle if they are purchasing plugs. But the system will not function correctly with both sides having the powerline receiving constant power. There will be a fix for this but any early 867SAs will have to be wired this way.

Note that this will only happen currently in circumstances where the strobe input is being powered on the 867SA-1 and 867SA-2 at the same time, and turn is applied for a period of time and then removed while strobe is being powered.
